# *THE SEISMIC RETROFIT OF HISTORIC BUILDINGS CONFERENCE WORKBOOK 1991*

# RECENT DEVELOPMENTS IN UNDERSTANDING THE SEISMIC PERFORMANCE OF HISTORIC ADOBE BUILDINGS

by E. Leroy Tolles, Frederick A. Webster,  
Charles C. Thiel Jr., Edna E. Kimbro, William S. Ginell  
Getty Seismic Adobe Project

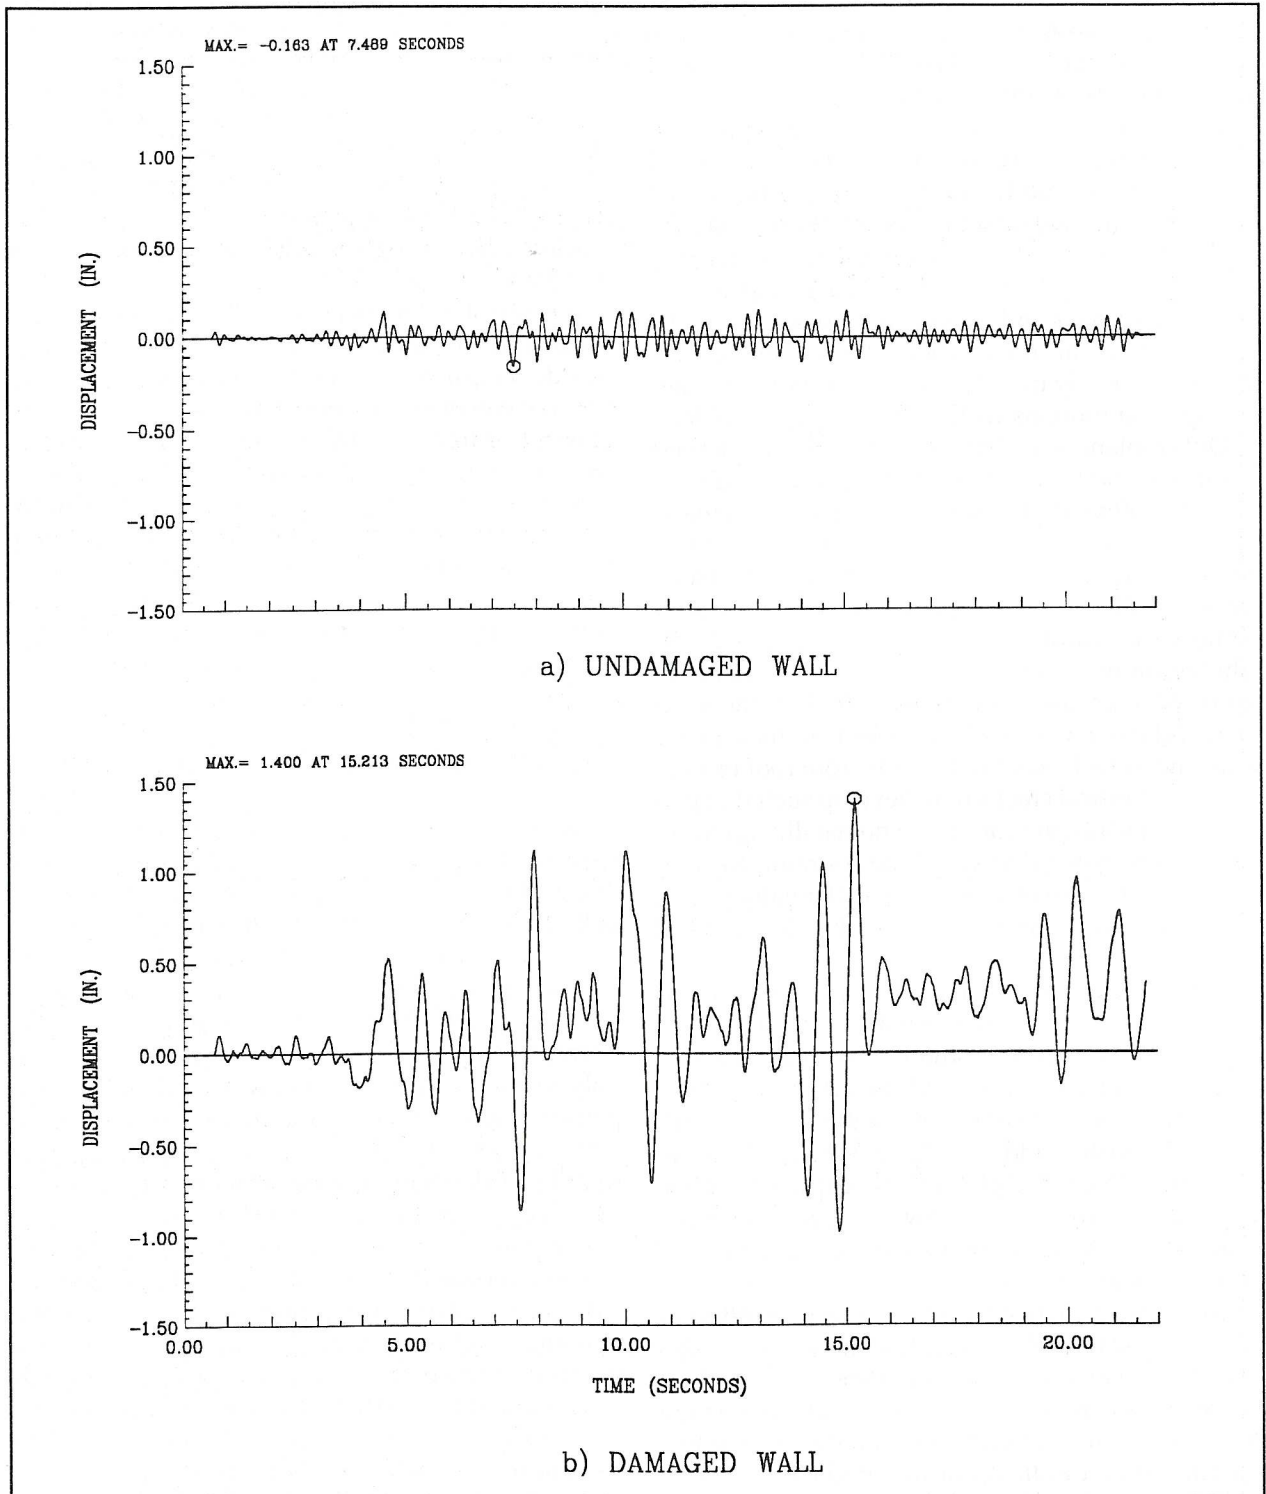
Figure 4. Out-of-plane displacements of damaged and undamaged walls.

The difference in out-of-plane wall displacements between damaged and undamaged buildings is best shown by a direct comparison of the out-of-plane displacements of a damaged and an undamaged building during the same test (Figure 4).

The displacements of the damaged building are nearly 10 times larger than those of the undamaged structure. The displacements shown in Figure 4 are still an order of magnitude less than required for overturning. Out-of-plane displacements of thick-walled adobe buildings can be quite large without threatening the stability of the walls.

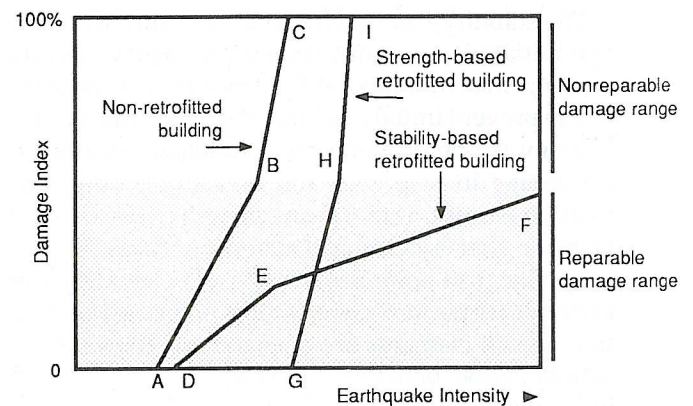
*Figure 10. Variations of damage index with severity of earthquake intensity comparing the expected performance of existing, strengthened and retrofitted buildings.*

The plot in Figure 10 is presented to represent graphically the progression of damage a collapse hazard adobe (e.g., one with thin walls and minimal roof and wall connections): one line (ABC) represents the building in its original condition; line DEF represents the damageability of the structure with a stability based retrofit; and, line GHI represents the damageability of the structure with a strength based retrofit. The horizontal axis is earthquake intensity which is merely a general term used to represent the severity of the earthquake ground motions. The vertical axis is the "damage index" (DI), which represents a qualitative assessment of structural damage ranging from non-damage to 100% damage. Figure 10 provides a graphic representation of the differences in damage

behavior of a locally strength-based retrofitted building and that of a stability-based retrofitted building. These lines describes the ending states for adobes in different stages of damage for different earthquake intensities. Strictly speaking, these are not curves that describe the progression of damage to a structure as the intense of ground motion increases during an individual earthquake.

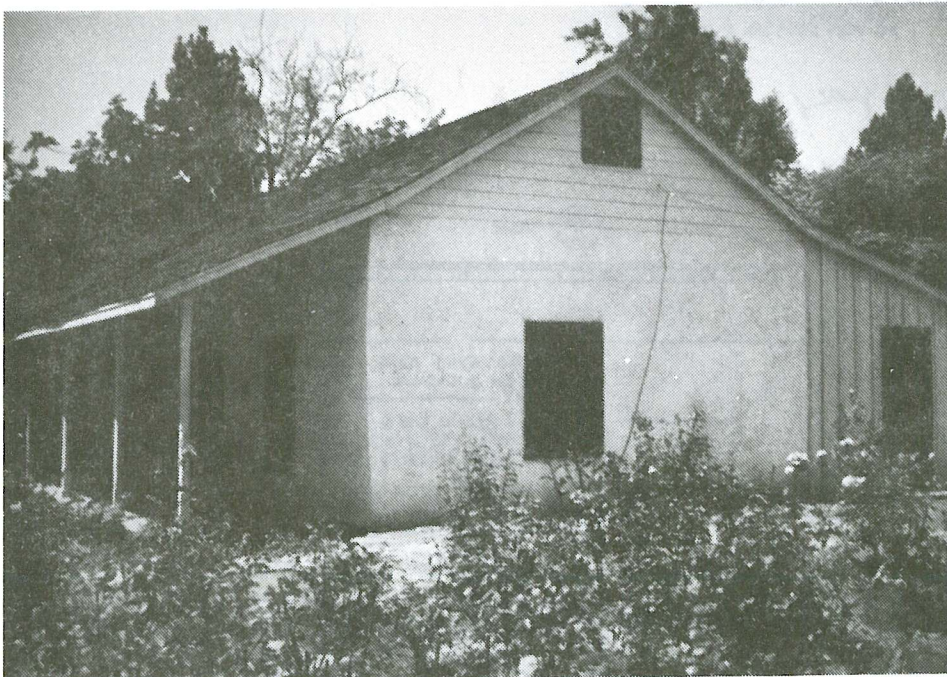
Figure 13. Photograph of La Casa Primera.

La Casa Primera (Figure 13) is a single-story historic adobe located in Pomona, California. It was built in 1837 and was the first adobe in the Pomona Valley (Scawthorn and Becker 1986). The original building plan was approximately 30 by 55 feet. Exterior walls are 11 feet high and 26 inches thick (slenderness ratio 5). Interior walls are approximately 14 inches thick. The foundation is adobe block.
